Appearance of Stroke Marks on the As-Cast Surface

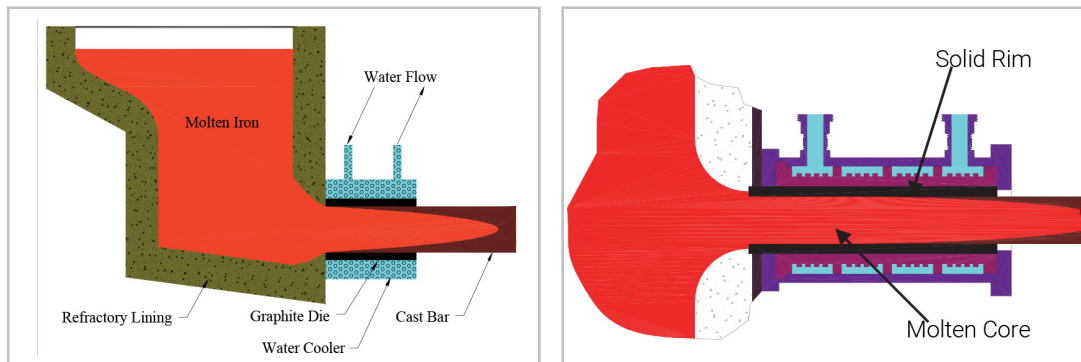
During the continuous casting process, molten iron enters a water-cooled graphite die that is mounted on the bottom of a refractory-lined steel holding vessel. The die/cooler system is maintained at a temperature of about 200° F and depending on the size and grade of the bar being cast, the molten iron will be approximately 2600° F. The molten iron at the inside surface of the graphite die is rapidly solidified and forms the rim of the bar which is the only part that is solid as it exits the die.

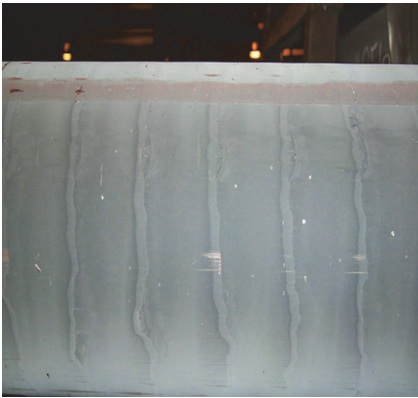
The casting process is by definition "continuous" but the bars are actually cast through the die in a series of strokes, about 2" long. Each time the bar strokes, molten iron enters the die from the bar machine crucible and forms the rim described above. Looking down the length of an as cast bar, the strokes will resemble oxide bands.

Careful measures are taken in the design of the die/cooler system and in the established process controls to minimize the depth of the stroke mark.
